PROJECT
Hare Lane, Chester

TITLE
Tree Constraints Plan

BS5837:2012 TREE SCHEDULE

REFERENCE: 1731-TS-V1-A

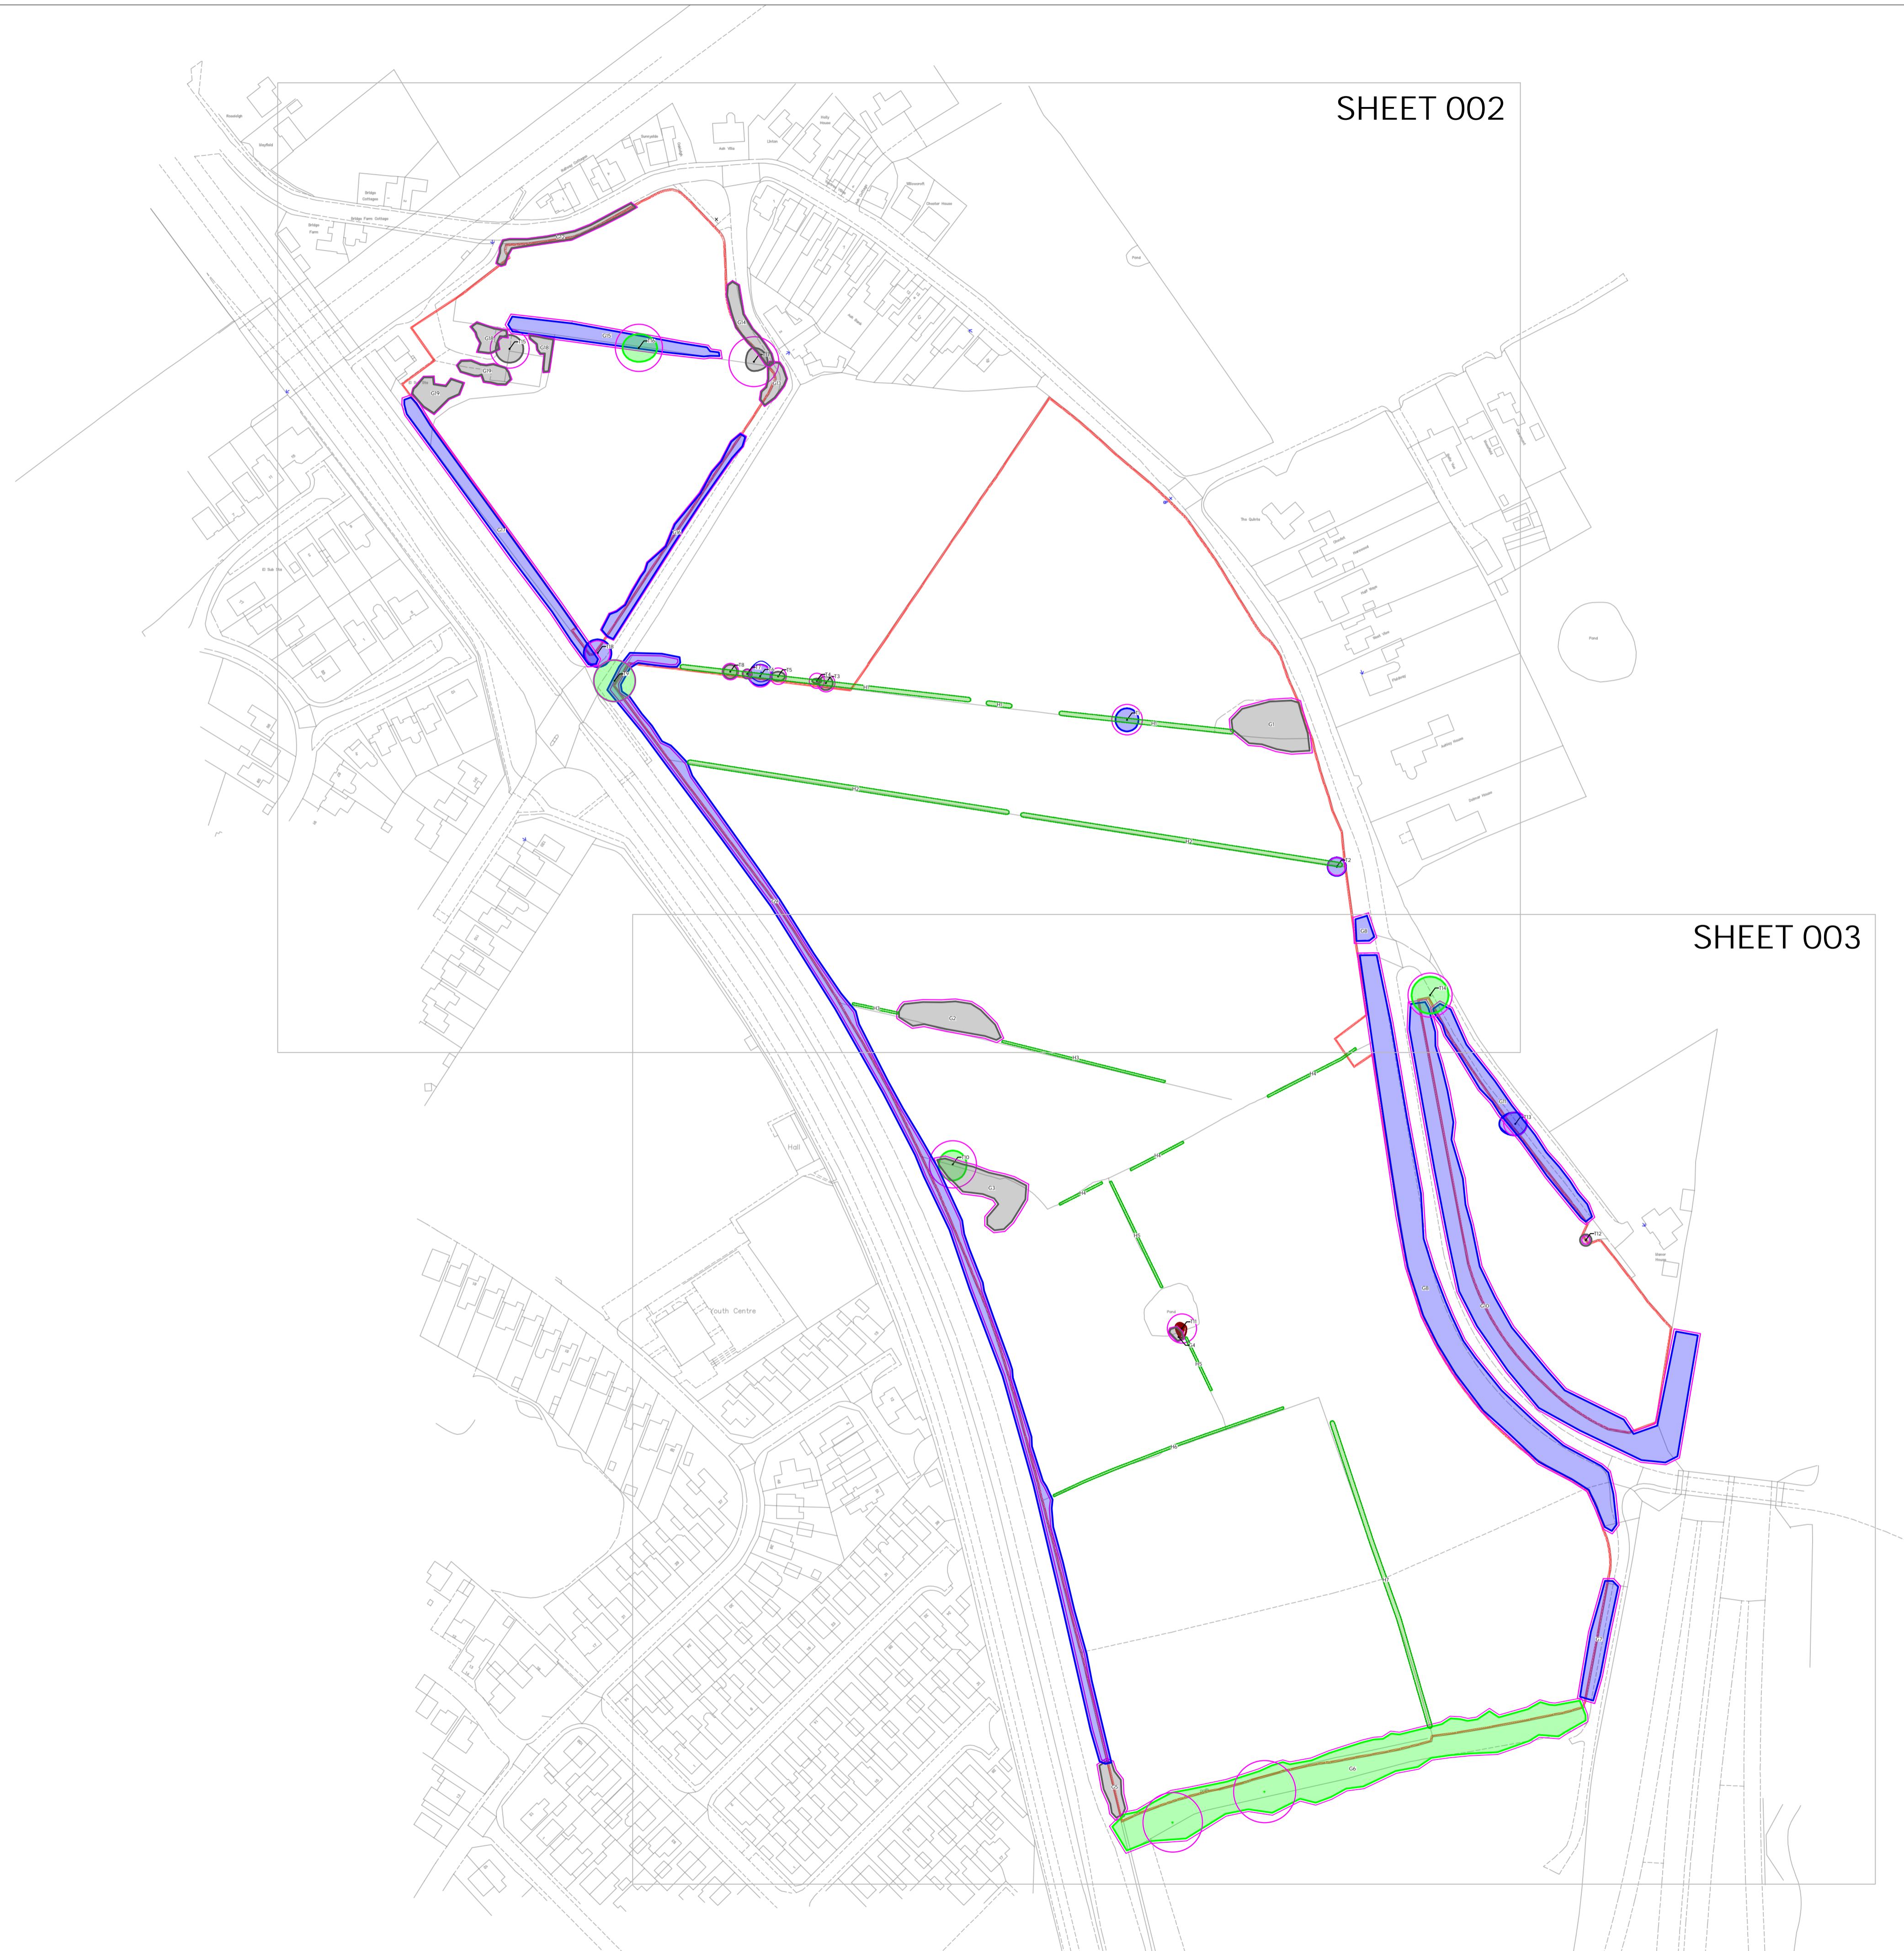
DRAWING NO
001

NOTES:
Tree locations are estimated from measurements on site. No topographical survey available at the time of tree survey.
